# Superior Stream Bank Protection

# MAGNUMSTONE'S SUPERIOR STREAM BANK PROTECTION

New Columbia, Pennsylvania, USA

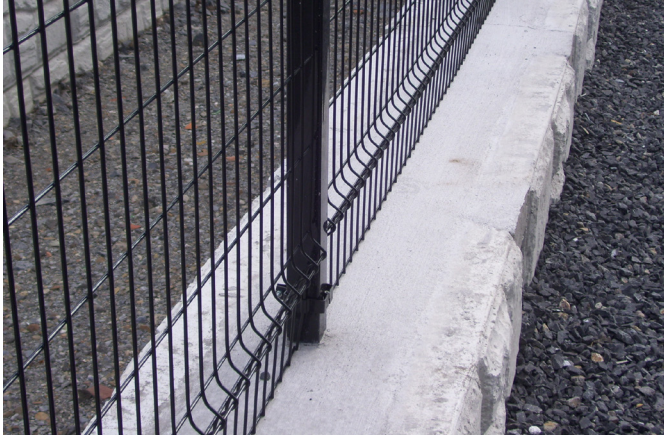
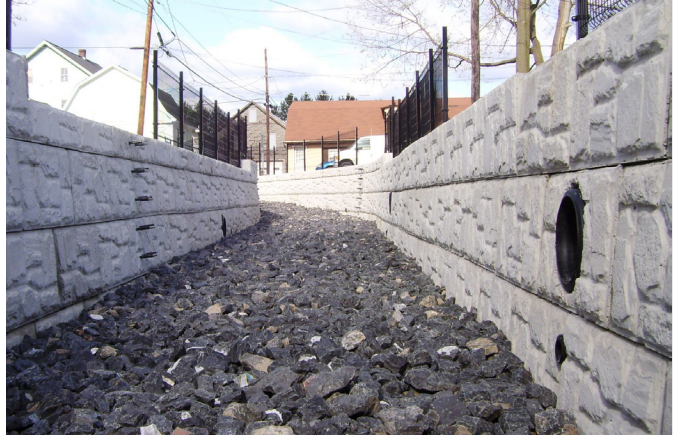
Double-sided blocks were utilized for the top course of the retaining wall stream banks as a barrier and parapet. To optimize land, a fence was mounted directly into the concrete-filled [hollow cores](#) of the MagnumStone blocks' top layer.

To prevent humans, wildlife and debris from getting caught in the stormwater system, additional safety measures were put in place along the MagnumStone streambeds. Fences were installed along large sections of the stream banks to deter falls and accidents around the stormwater system.

Ladder rungs were also incorporated into the system design for deep areas where children could potentially get caught during storm surges. This excellent feature by ELA Group emphasizes the importance of safety among the multitude of hazards that can arise from storm scenarios.
