## Emergency MagnumStone Wall Rescues Home After Hurricane

# EMERGENCY MAGNUMSTONE WALL RESCUES HOME AFTER HURRICANE

Maggie Valley, North Carolina, USA

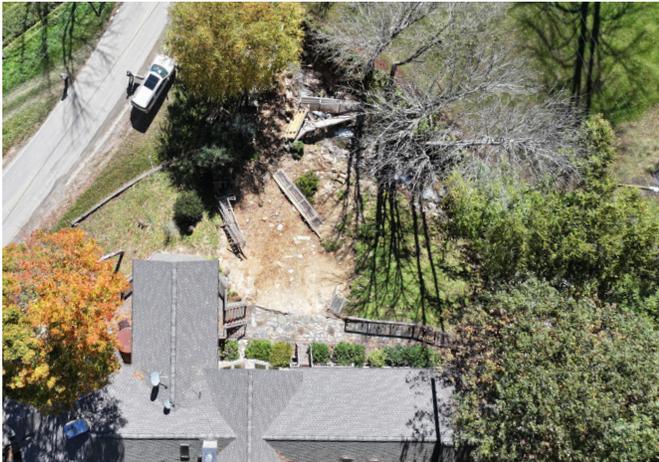
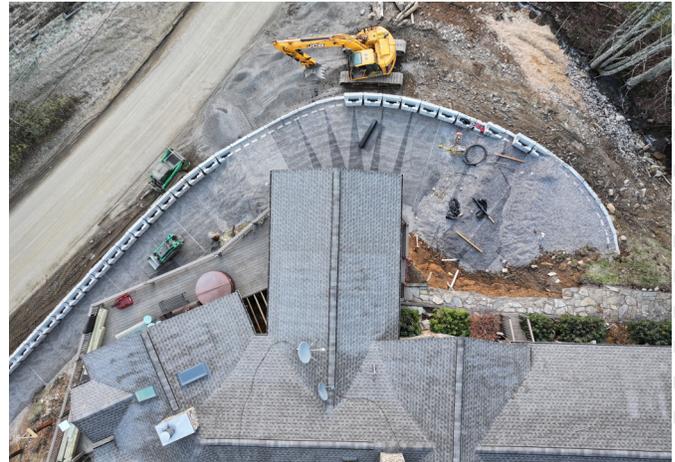
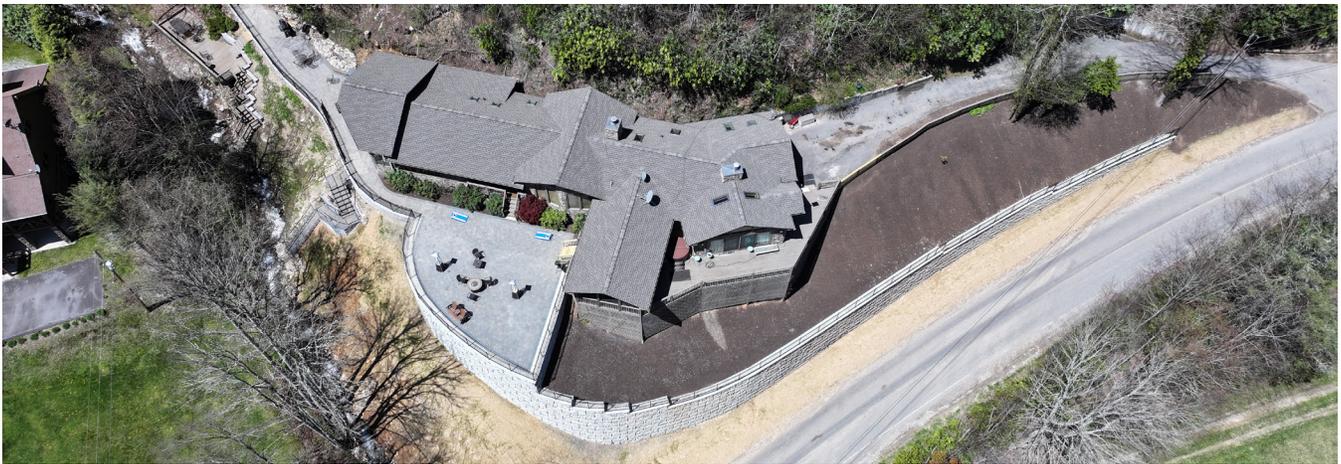
This vacation home's steep slope in Maggie Valley, North Carolina, was in severe danger of collapsing after Hurricane Helene. The hurricane devastated the region in September 2024, damaging properties and destroying infrastructure with widespread flooding and erosion. Surging stormwater from a nearby stream caused major erosion, compromising the structure's foundation, entrenched on the hillside.

After extensive on-site analyses, experts at Engineered Retaining Walls chose MagnumStone's retaining wall system for slope stabilization and reinforcement. The blocks' precast strength and versatility delivered a durable tiered wall, contoured to the residential property's naturally vertical, curved terrain.

With outstanding support from local MagnumStone producer, [Valley Precast](#) based in Waynesville, NC, the retaining wall was crucial to this complex geotechnical rescue. It totals over 4,500 sq. ft. (420 sq. m.), reaching 240 ft. (73 m.) wide and a maximum height of 22 ft. (6.7 m.). The geogrid wall design successfully stabilized the property and created more usable space above the wall.

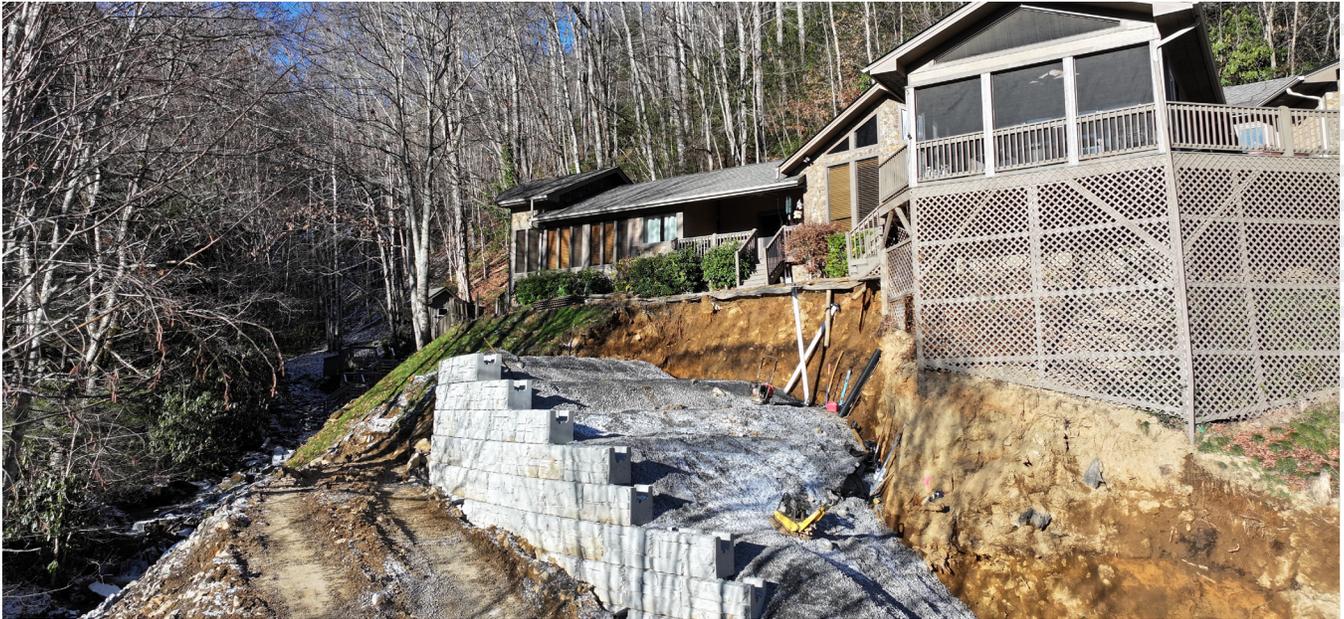
This project presented several urgent and complex challenges, including rapid slope failure directly beneath the home's foundation, compromising its safety. The swift response, strategic planning, and MagnumStone's reinforced retaining wall contributed to fortifying the quickly eroding mountainside property.

To deal with unstable soil conditions, steep terrain and limited construction access, a large weight distribution pad was built. This elevated the wall's foundation and created a platform for heavy equipment to construct the MagnumStone retaining wall.

The precast blocks were installed entirely from in front of the wall, using a long-reach excavator to overcome access limitations. The retaining wall allowed the homeowner to develop and transform the steep overgrown hillside into a hardscaped outdoor living space.

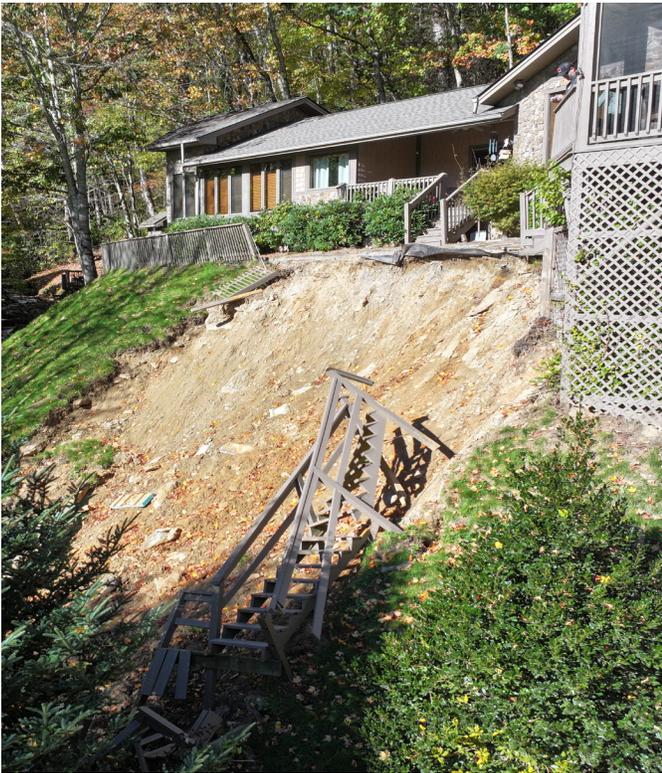
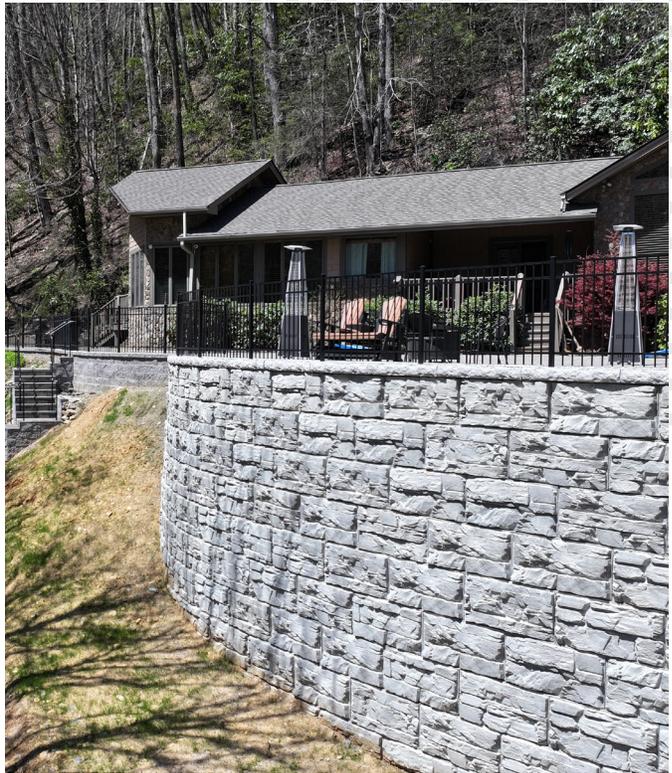
They chose MagnumStone's hollow core block system because of its superior drainage and success with previous challenging retaining wall projects. MagnumStone's integrated drainage channels help mitigate hydrostatic pressures from accumulating behind the wall. This was a critical wall design consideration due to the region's persistent heavy rainfalls and the site's groundwater infiltration.

The [geogrid wall design](#) was built on a large weight distribution pad composed of Class B riprap. This raised the retaining wall's foundation, to provide stability and allow sufficient geogrid reinforcement. It also created an accessible area for equipment to install the retaining wall blocks from, in front of the wall.

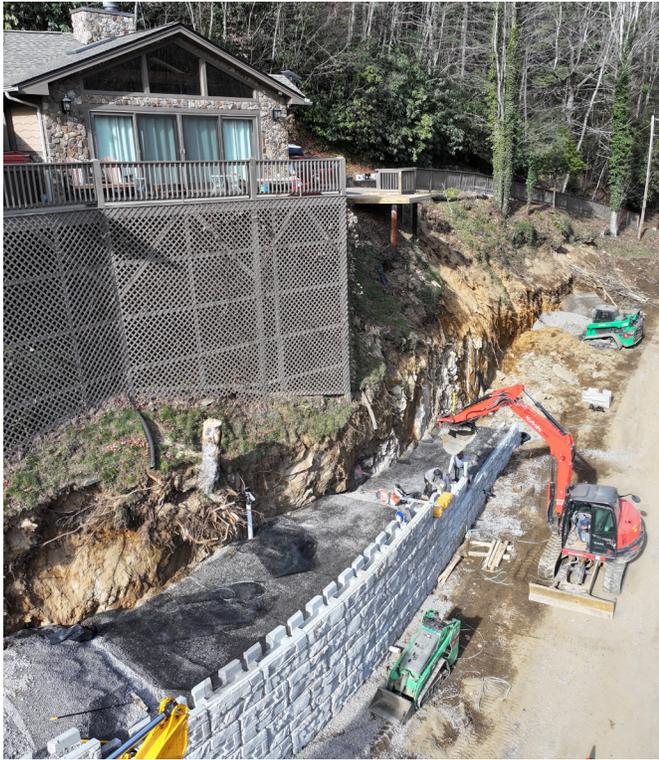
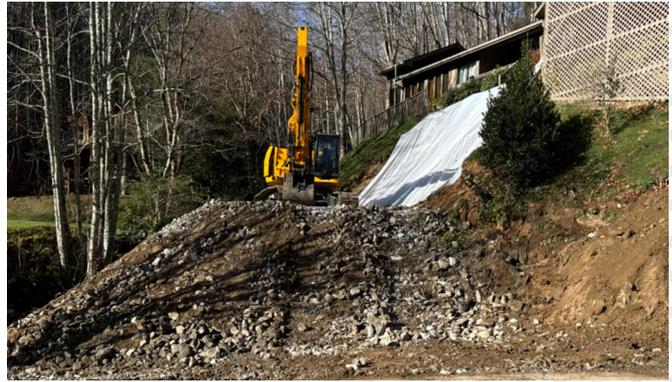
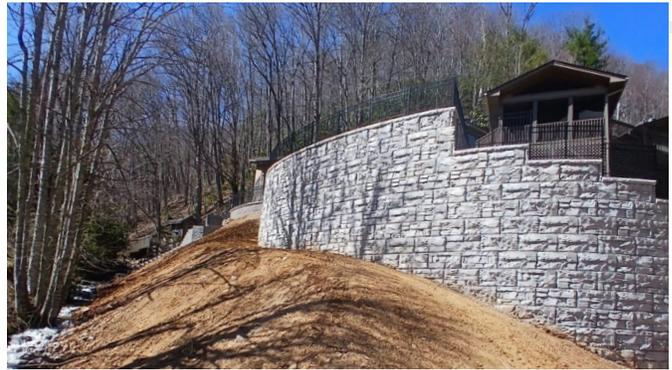
Experts at Engineered Retaining Walls wasted no time on this project, beginning construction just one week after the initial consultation. The new weight distribution pad served as a stable platform for the long-reach excavator to install a MagnumStone wall. The [hollow core blocks](#) reduced weight and were easier to lift and position, reaching heights of 22 ft. (6.7 m.). This was a major advantage while working on a dangerous, exposed slope.

Each standard MagnumStone unit covers 8 sq. ft. (0.74 sq. m.) of block facing, which expedited construction. This quickly stabilized the site and protected the home from further damage. It also minimizing block quantities and their associated truckloads. SecureLugs along the base of the blocks interlocked into the courses below to ensure consistent alignment and setback.

Rock veins throughout the excavation area were another complication, which required precision jackhammering to remove. Crush drainage gravel was then installed and compacted within the blocks' hollow cores to regain mass and promote drainage efficiency. The MagnumStone geogrid wall fortified the hillside with precise placement and even load distribution.

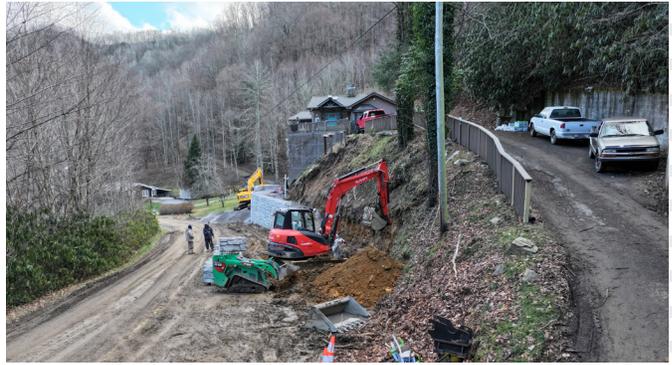
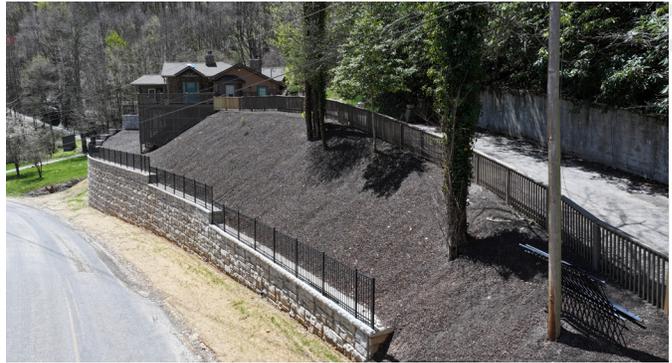
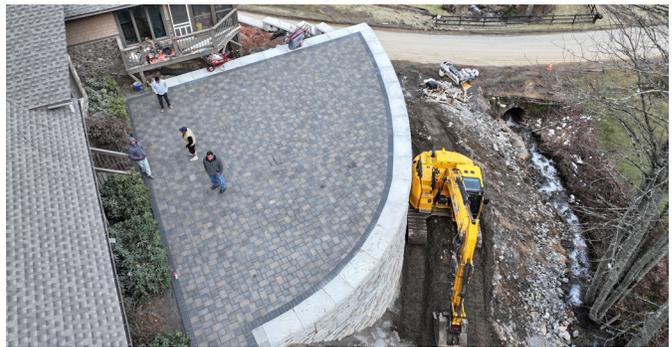
While safety and performance were paramount to this project, it helped that the blocks integrated well with the property's landscape. MagnumStone's rugged, [natural stone appearance](#) suited the mountainous backdrop of Maggie Valley. The blocks blend into the forested terrain and add to the home's rustic aesthetic.

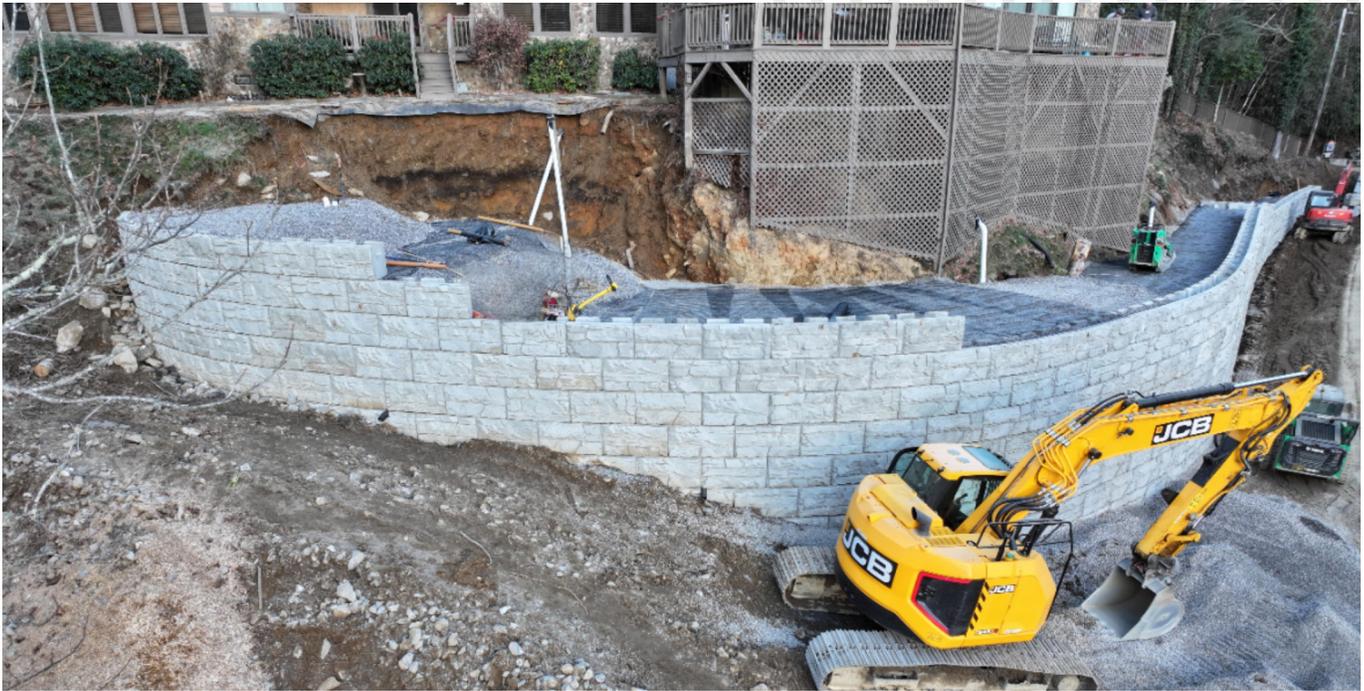
Following the aftermath of Hurricane Helene in Maggie Valley, NC, this hillside home's foundation was critically endangered by severe erosion. Local professionals, Engineered Retaining Walls and UES, urgently responded, selecting a trusted precast retaining wall system to fortify the slope. MagnumStone's high-strength durability, drainage capabilities, and adaptability was deemed the best long-term solution for the site's steep, unstable conditions.
