Stillwater Riverbank Restoration

STILLWATER RIVERBANK RESTORATION

Dayton, OH, USA

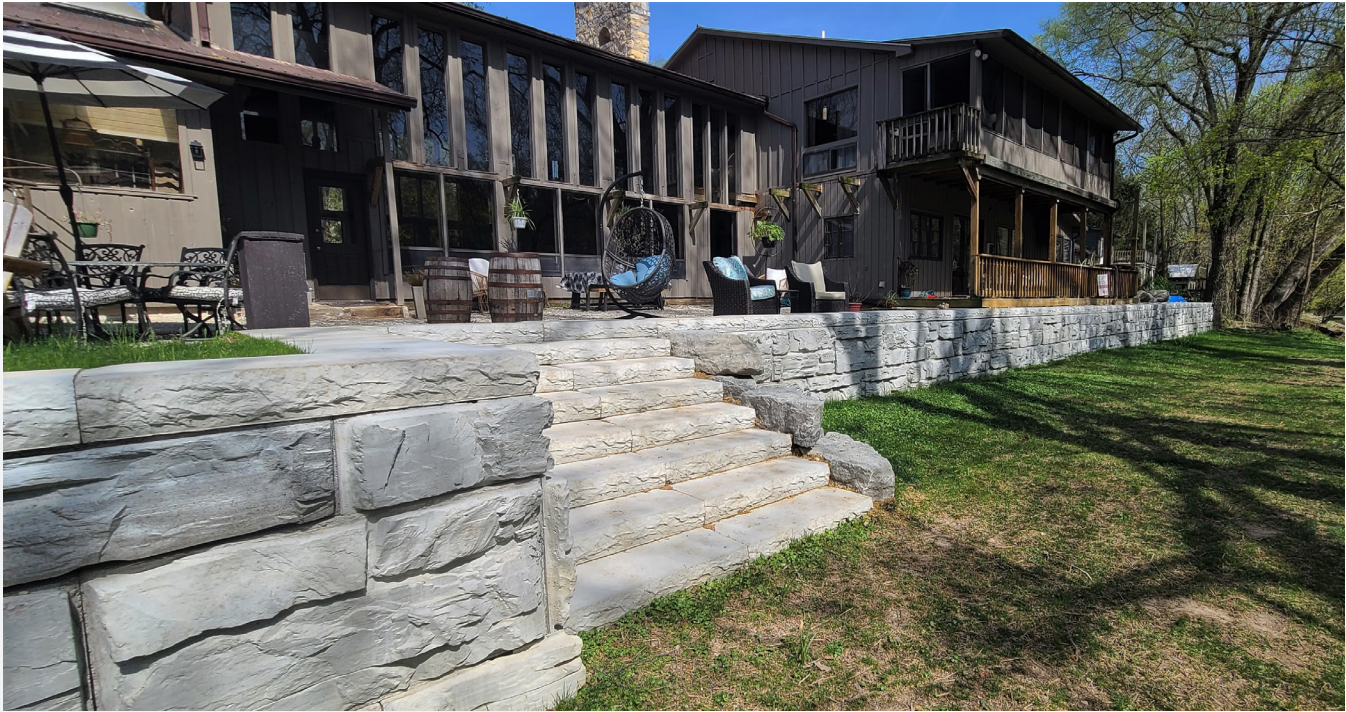
Along the Stillwater River in Dayton, Ohio, MagnumStone blocks delivered a strong, long-lasting solution and natural stone look for the stunning [Stillwater River Lodge](#). Using MagnumStone blocks from local producer [Oberfields LLC](#), the experts at [FSR Landscaping](#) designed the wall and stair treads built with cap units. Their team also installed all of the precast units, placing them in front of an aging masonry wall to extend the raised patio and green space along the top tier.

This unique terraced backyard design gives guests the ultimate relaxation area. The MagnumStone gravity retaining wall reaches a maximum height of 5 ft. (1.52 m.) and stretches 226 ft. (69 m.) along the beautiful riverside property. The hollow core blocks are backfilled with crush gravel for extra mass and to enhance drainage and better protect the wall in the event of high rising seasonal waters.
